January 30, 2013

**Subject:** Test Section Summary  
Crumb Rubber Modified 9.5mm SP HMA  
Including Pre-blended Elastico Additive

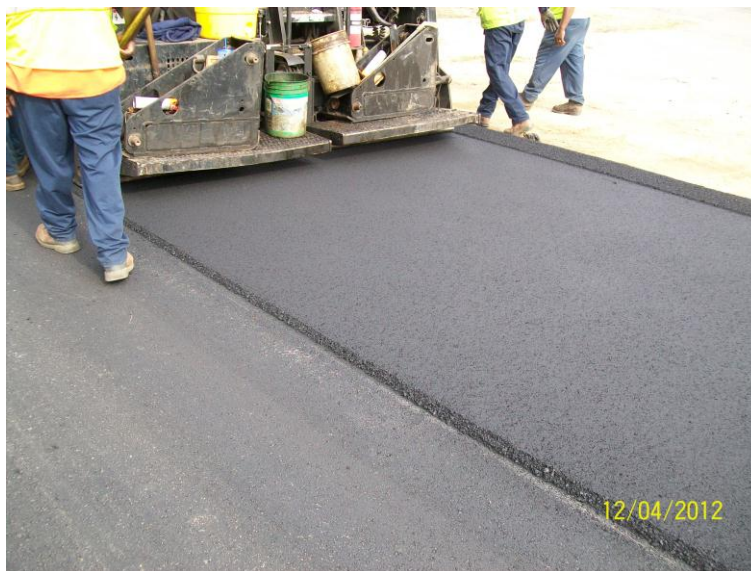
Prior to modifying the 9.5mm mix with CR/Elastico, the in-place mat exhibited frequent pulling and tearing due to a long haul distance and inconsistent placement operations. In addition to multiple short pulls and tie-ins on numerous streets, the mix frequently fell below optimum placement temperature. Mix temperatures ranged from 310 F down to 275 F. Although once the CRM was added, the uncompacted mat directly behind the screed appeared to be noticeably slicker/richer and more workable with uniform mat texture (See Photo 1).

PHOTO 1, CRM Modified Uncompacted Mat

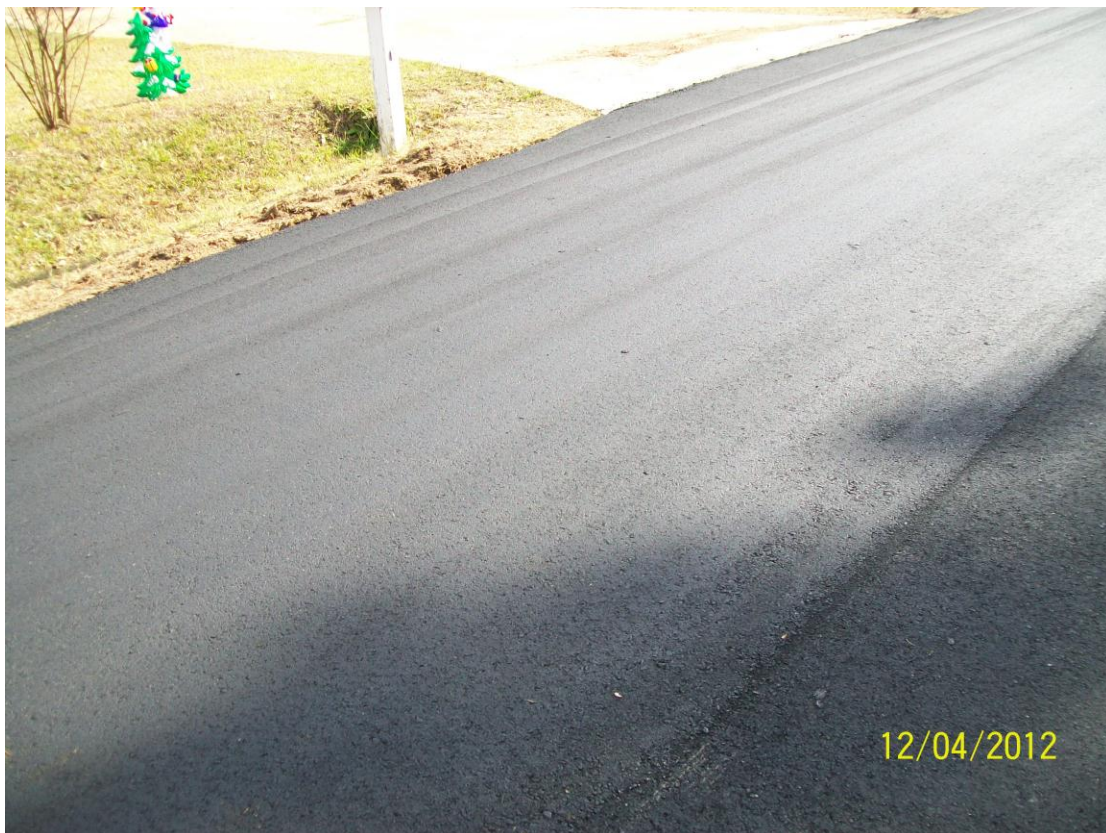
Although, visual observations of the mat with the elastico additive after the rubber tire placed the established number of passes did not display any signs of pickup or pull/tearing (See photo 2).

PHOTO 2, Mat after the Rubber Tire Roller.
